COLUMBIA

ACCIDENT INVESTIGATION BOARD

REPORT VOLUME I
AUGUST 2003

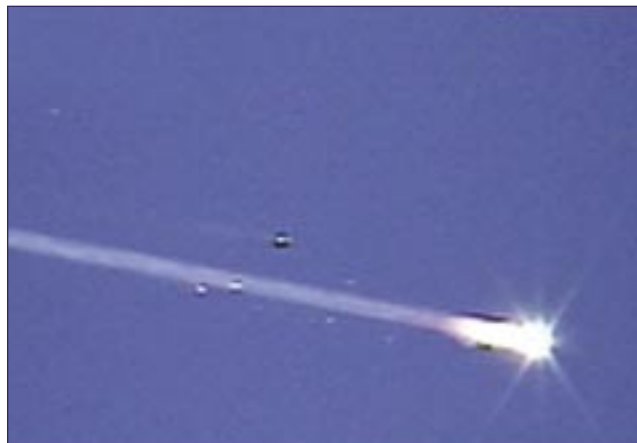
The Orbiter has a large glowing field surrounding it in this view taken from Mesquite, Texas, looking south.

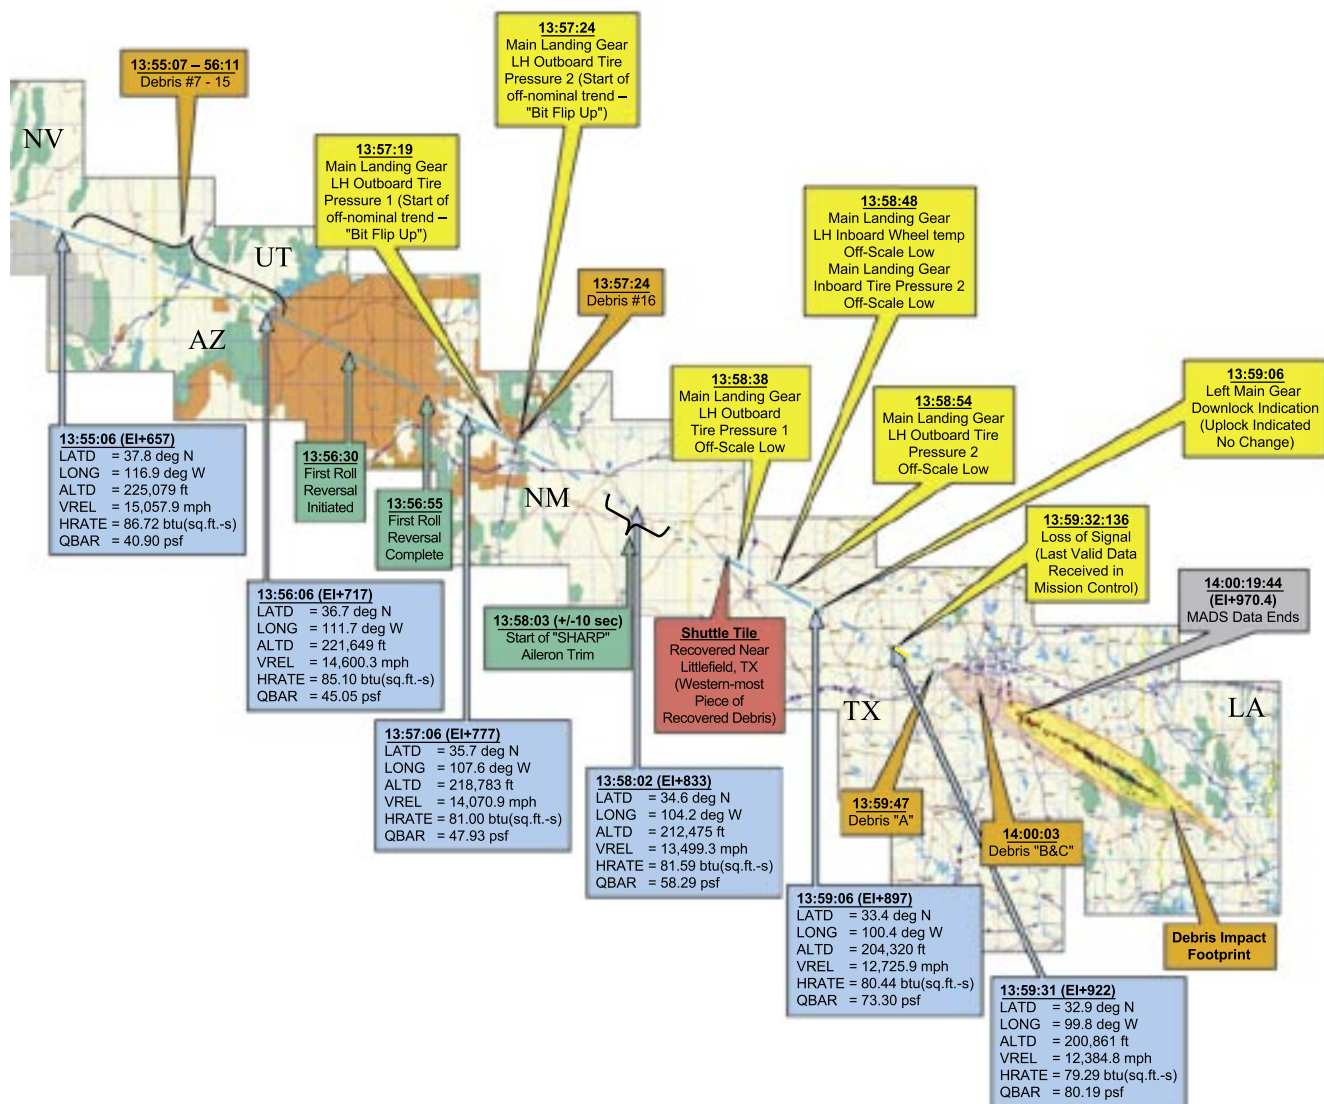
STS-107 Re-entry Trajectory and Timeline (First Off-Nominal Event to Loss of Signal)

At 8:48:39 a.m. (EI+270), a sensor on the left wing leading edge spar showed strains higher than those seen on previous *Columbia* re-entries. This was recorded only on the Modular Auxiliary Data System, and was not telemetered to ground controllers or displayed to the crew (see Figure 2.6-1).

Figure 2.6-1. This simplified timeline shows the re-entry path of Columbia on February 1, 2003. The information presented here is a composite of sensor data telemetered to the ground combined with data from the Modular Auxiliary Data System recorder recovered after the accident. Note that the first off-nominal reading was a small increase in a strain gauge at the front wing spar behind RCC panel 9-left. The chart is color-coded: blue boxes contain position, attitude, and velocity information; orange boxes indicate when debris was shed from the Orbiter; green boxes are significant aerodynamic control events; gray boxes contain sensor information from the Modular Auxiliary Data System; and yellow boxes contain telemetered sensor information. The red boxes indicate other significant events.

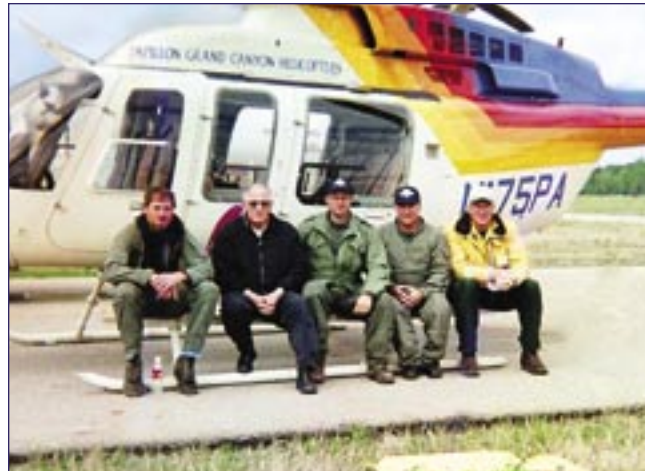
Figure 2.7-3. Tragically, a helicopter crash during the debris search claimed the lives of Jules "Buzz" Mier (in black coat) and Charles Krenek (yellow coat).

ty of the East Texas vegetation, the small sizes of the debris, and the inability of sensors to differentiate Orbiter material from other objects, these devices proved of little value. As a result, the detection work fell to spotter teams who visually scanned the terrain. Air search coordinators apportioned grids to allow a 50 percent probability of detection for a one-foot-square object. Civil Air Patrol volunteers and others in powered parachutes, a type of ultralight aircraft, also participated in the search, but were less successful than helicopter and fixed-wing air crews in retrieving debris. During the air search, a Bell 407 helicopter crashed in Angelina National Forest in San Augustine County after a mechanical failure. The accident took the lives of Jules F. "Buzz" Mier Jr., a contract pilot, and Charles Krenek, a Texas Forest Service employee, and injured three others (see Figure 2.7-3).

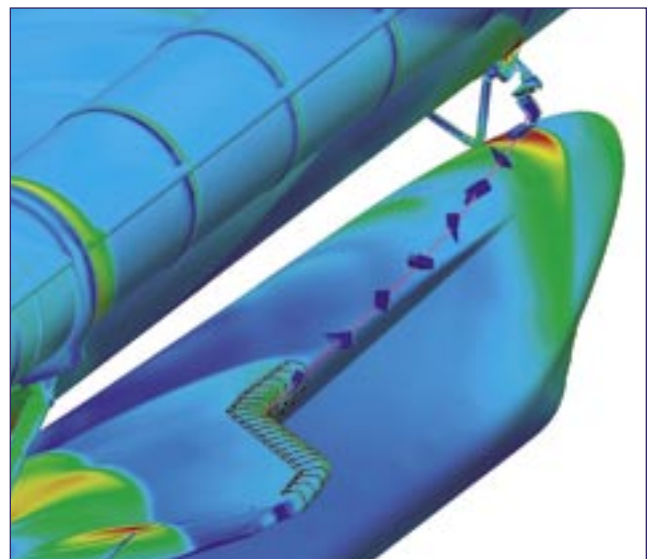
The team identified a relatively narrow range of foam impact velocities and ballistic coefficients. The ballistic coefficient of an object expresses the relative influence of weight and atmospheric drag on it, and is the primary aerodynamic characteristic of an object that does not produce lift. An object with a large ballistic coefficient, such as a cannon ball, has a trajectory that can be computed fairly accurately without accounting for drag. In contrast, the foam that struck the wing had a relatively small ballistic coefficient with a large drag force relative to its weight, which explains why it slowed down quickly after separating from the External Tank. Just prior to separation, the speed of the foam was equal to the speed of the Shuttle, about 1,568 mph (2,300 feet per second). Because of a large drag force, the foam slowed to about 1,022 mph (1,500 feet per second) in about 0.2 seconds, and the Shuttle struck the foam at a relative

Figure 3.4-6. These are the results of a trajectory analysis that used a computational fluid dynamics approach in a program called CART-3D, a comprehensive (six-degree-of-freedom) computer simulation based on the laws of physics. This analysis used the aerodynamic and mass properties of bipod ramp foam, coupled with the complex flow field during ascent, to determine the likely position and velocity histories of the foam.

The undetermined and yet certainly irregular shape of the foam introduced substantial uncertainty about its estimated aerodynamic characteristics. Appendix D.8 contains an independent analysis conducted by the Board to confirm that the estimated range of ballistic coefficients of the foam in Figure 3.4-6 was credible, given the foam dimension results from the image analyses and the expected range of the foam density. Based on the results in Figure 3.4-7, the physical dimensions of the bipod ramp, and the sizes and shapes of the available barrels for the compressed-gas gun used in the impact test program described later in this chapter, the Board and the NASA Accident Investigation Team decided that a foam projectile 19 inches by 11.5 inches by 5.5 inches, weighing 1.67 pounds, and with a weight density of 2.4 pounds per cubic foot, would best represent the piece of foam that separated from the External Tank bipod ramp and was hit by the Orbiter’s left wing. See Section 3.8 for a full discussion of the foam impact testing.

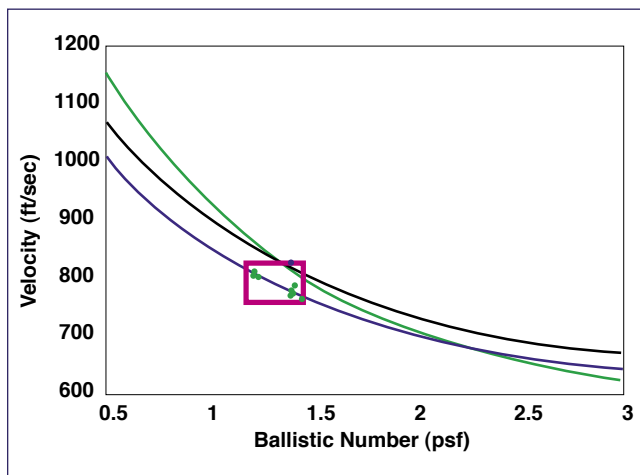
Figure 3.4-7. The results of numerous possible trajectories based on various assumed sizes, shapes, and densities of the foam. Either the foam had a slightly higher ballistic coefficient and the Orbiter struck the foam at a lower speed relative to the Orbiter, or the foam was more compact and the wing struck the foam at a higher speed. The “best fit” box represents the overlay of the data from the image analysis with the transport analysis computations. This data enabled a final selection of projectile characteristics for impact testing.

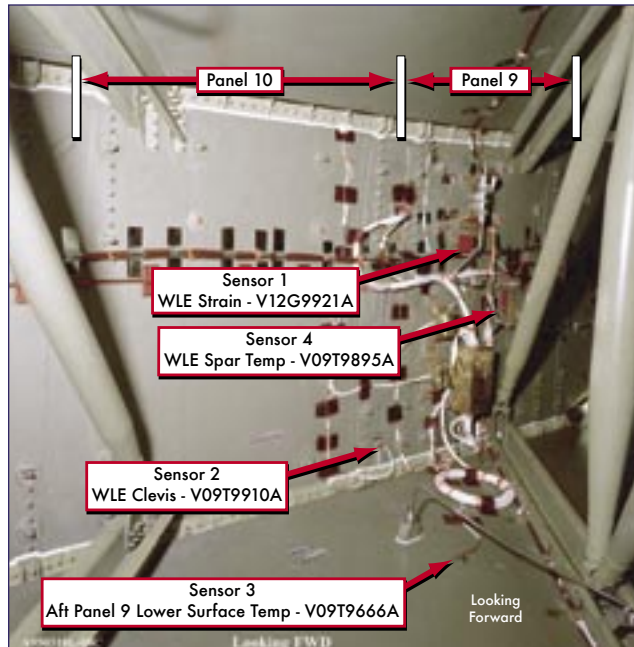
Figure 3.6-2. Location of sensors on the back of the left wing leading edge spar (vertical aluminum structure in picture). Also shown are the round truss tubes and ribs that provided the structural support for the mid-wing in this area.

or outside the wing leading edge spar near Reinforced Carbon-Carbon (RCC) panel 9-left, helped tell the story of what happened on the left wing of the Orbiter early in the re-entry. These four sensors were: strain gauge V12G9921A (Sensor 1), resistance temperature detector V09T9910A on the RCC clevis between panel 9 and 10 (Sensor 2), thermocouple V07T9666A, within a Thermal Protection System tile (Sensor 3), and resistance temperature detector V09T9895A (Sensor 4), located on the back side of the wing leading edge spar behind RCC panels 8 and 9 (see Figure 3.6-2).

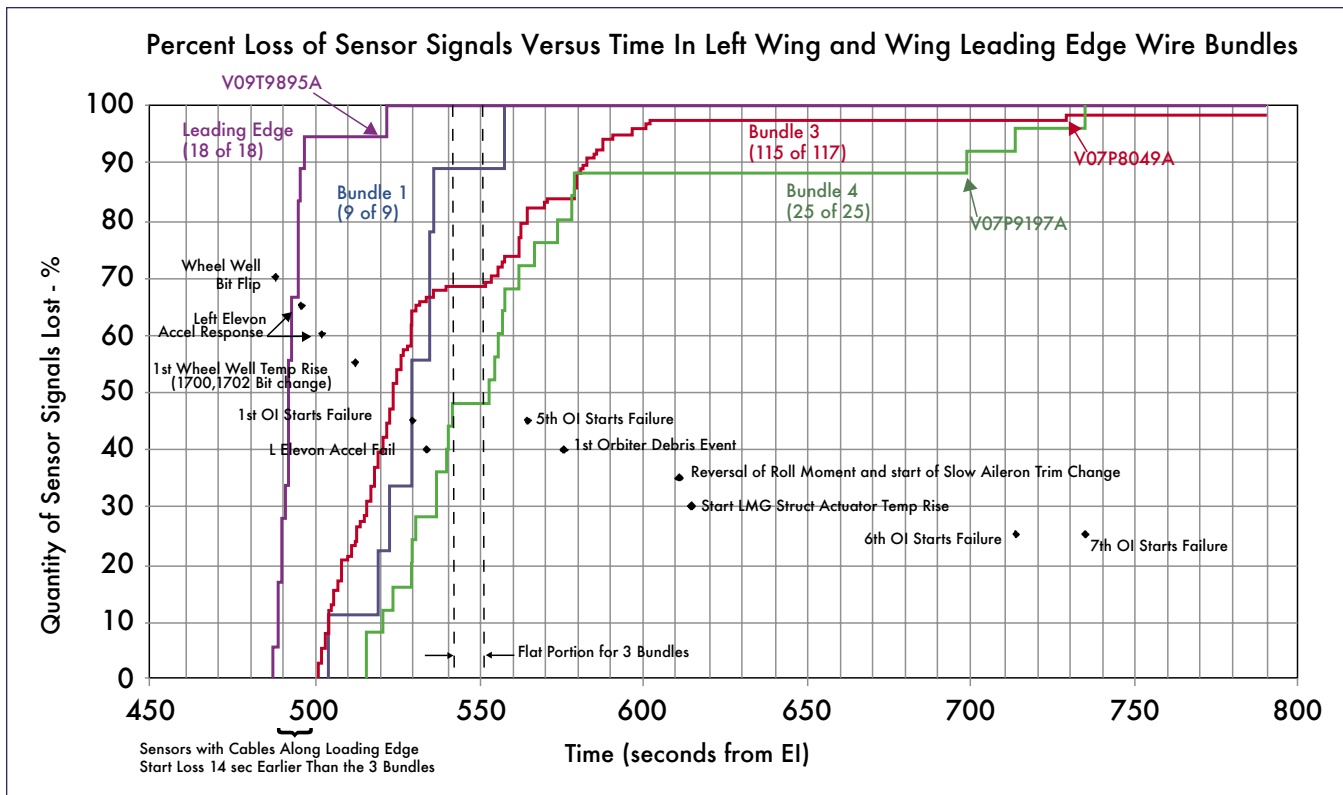
Fourteen seconds after the loss of the first sensor wire on the wing leading edge spar at EI+487, a sensor wire in a bundle of some 150 wires that ran along the upper outside corner of the left wheel well showed a burn-through. In the next 50 seconds, more than 70 percent of the sensor wires in three cables in this area also burned through (see Figure 3.6-10). Investigators plotted the wiring run for every left-wing sensor, looking for a relationship between their location and time of failure.

Figure 3.6-10. This chart shows how rapidly the wire bundles in the left wing were destroyed. Over 70 percent of the sensor wires in the wiring bundles burned through in under a minute. The black diamonds show the times of significant timeline sensor events.

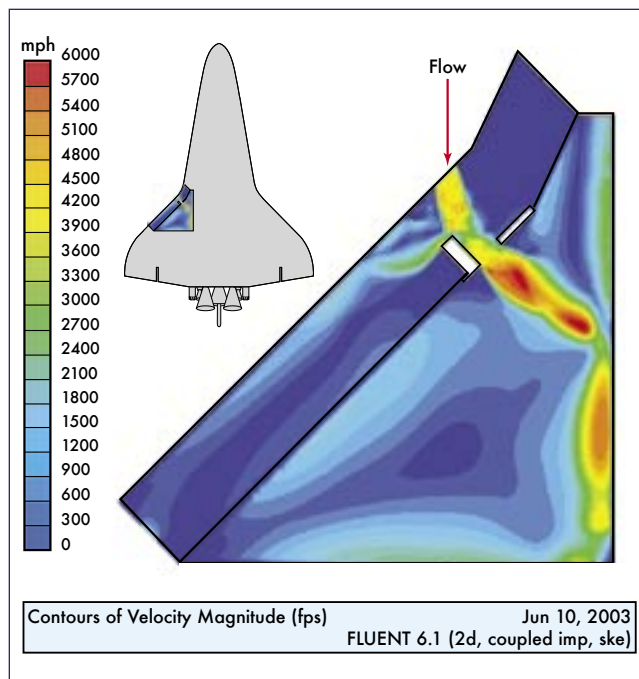
Later computational fluid dynamics analysis of the mid-wing area behind the spar showed that superheated air flowing into a breached RCC panel 8 and then interacting with the internal structure behind the RCC cavity (RCC ribs and spar insulation) would have continued through the wing leading edge spar as a jet, and would have easily allowed superheated air to traverse the 56.5 inches from the spar to the outside of the wheel well and destroy the cables (Figure 3.6-11). Controllers on the ground saw these first anomalies in the telemetry data at EI+613, when four hydraulic sensor cables that ran from the aft part of the left wing through the wiring bundles outside the wheel well failed.

Figure 3.6-11. The computational fluid dynamics analysis of the speed of the superheated air as it entered the breach in RCC panel 8 and then traveled through the wing leading edge spar. The darkest red color indicates speeds of over 4,000 miles per hour. Temperatures in this area likely exceeded 5,000 degrees Fahrenheit. The area of detail is looking down at the top of the left wing.

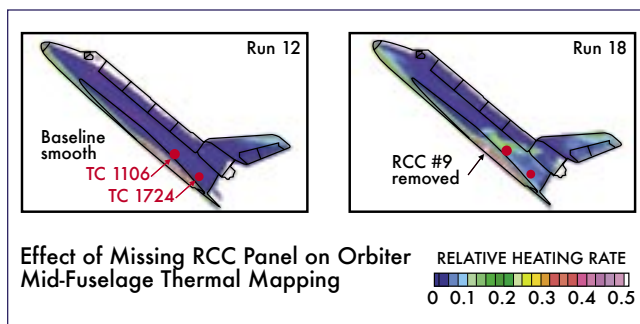
Figure 3.6-13. The effects of removing RCC panel 9 are shown in this figure. Note the brighter colors on the front of the OMS pod show increased heating, a phenomenon supported by both the OMS pod temperature sensors and the debris analysis.

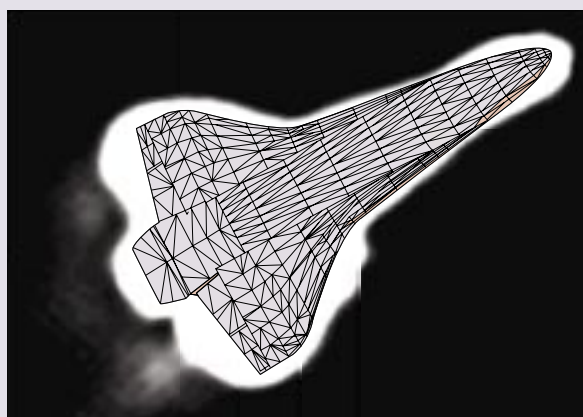
The image shows an unusual condition on the left wing, a leading-edge disturbance that might indicate damage. Several analysts concluded that the distortion evident in the image likely came from the modification and interaction of shock waves due to the damaged leading edge. The overall appearance of the leading-edge damage at this point on the trajectory is consistent with the scenario.

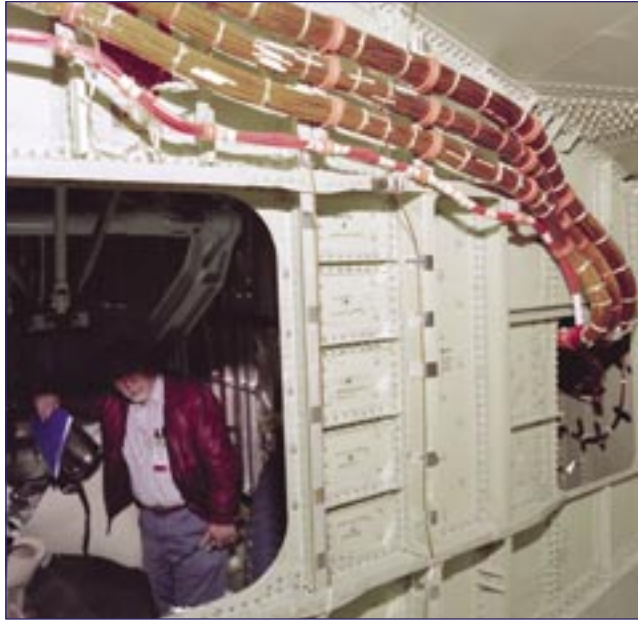
Figure 4.2-3. Typical wiring bundle inside Orbiter wing.

A typical wiring bundle is shown in Figure 4.2-3. Wiring nonconformances are corrected by rerouting, reclamping, or installing additional insulation such as convoluted tubing, insulating tape, insulating sheets, heat shrink sleeving, and abrasion pads (see Figure 4.2-4). Testing has shown that wiring bundles usually stop arc tracking when wires are physically separated from one another. Further testing under conditions simulating the Shuttle's wiring environment demonstrated that arc tracking does not progress beyond six inches. Based on these results, Boeing recommended that NASA separate all critical paths from larger wire bundles and individually protect them for a minimum of six inches beyond their separation points.⁴ This recommendation is being adopted through modifications performed during scheduled Orbiter Major Modifications. For example, analysis of telemetered data from 14 of *Columbia's* left wing sensors (hydraulic line/wing skin/wheel temperatures, tire pressures, and landing gear downlock position indication) provided failure signatures supporting the scenario of left-wing thermal intrusion, as opposed to a catastrophic failure (extensive arc tracking) of Kapton wiring. Actual NASA testing in the months following the accident, during which wiring bundles were subjected to intense heat (ovens, blowtorch, and arc jet), verified the failure signature analyses. Finally, extensive testing and analysis in years prior to STS-107 showed that, with the low currents and low voltages associated with the Orbiter's instrumentation system (such as those in the left wing), the probability of arc tracking is commensurately low.

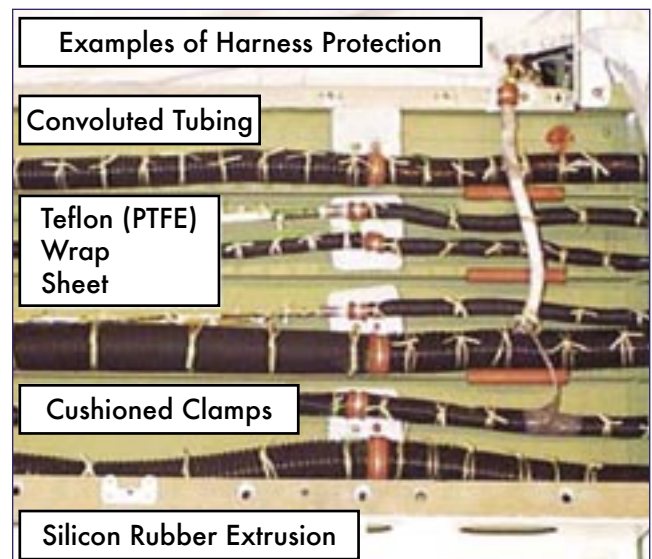
Figure 4.2-4. Typical wiring harness protection methods.

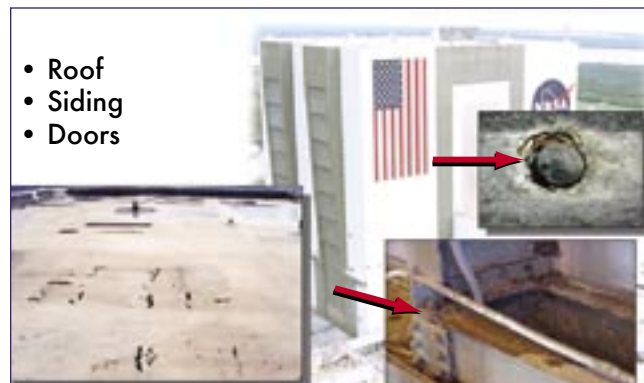
Board investigators have identified deteriorating infrastructure associated with the launch pads, Vehicle Assembly Building, and the crawler transporter. Figures 5.5-5 and 5.5-6 depict some of this deterioration. For example, NASA has installed nets, and even an entire sub-roof, inside the Vehicle Assembly Building to prevent concrete from the building’s ceiling from hitting the Orbiter and Shuttle stack. In addition, the corrosion-control challenge results in zinc primer

on certain launch pad areas being exposed to the elements. When rain falls on these areas, it carries away zinc, runs onto the leading edge of the Orbiter’s wings, and causes pinholes in the Reinforced Carbon-Carbon panels (see Chapter 3).

Figure 5.5-5 and 5.5-6. Examples of the seriously deteriorating infrastructure used to support the Space Shuttle Program. At left is Launch Complex 39A, and at right is the Vehicle Assembly building, both at the Kennedy Space Center.

In 2000, NASA identified 100 infrastructure items that demanded immediate attention. NASA briefed the Space Flight Advisory Committee on this “Infrastructure Revitalization” initiative in November of that year. The Committee concluded that “deteriorating infrastructure is a serious, major problem,” and, upon touring several Kennedy Space Center facilities, declared them “in deplorable condition.”⁶⁷ NASA subsequently submitted a request to the White House Office of Management and Budget during Fiscal Year 2002 budget deliberations for \$600 million to fund the infrastructure initiative. No funding was approved.

In Fiscal Year 2002, Congress added \$25 million to NASA’s budget for Vehicle Assembly Building repairs. NASA has reallocated limited funds from the Shuttle budget to pressing infrastructure repairs, and intends to take an integrated look at infrastructure as part of its new Shuttle Service Life Extension Program. Nonetheless, like Space Shuttle upgrades, infrastructure revitalization has been mired by the uncertainty surrounding the Shuttle Program’s lifetime. Considering that the Shuttle will likely be flying for many years to come, NASA, the White House, and Congress alike now face the specter of having to deal with years of infrastructure neglect.

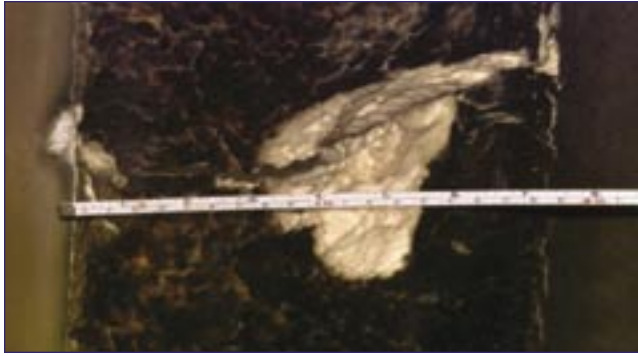
The sixth and final bipod ramp event before STS-107 occurred during STS-112 on October 7, 2002 (see Figure 6.1-3). At 33 seconds after launch, when *Atlantis* was at 12,500 feet and traveling at Mach 0.75, ground cameras observed an object traveling from the External Tank that subsequently impacted the Solid Rocket Booster/External Tank Attachment ring (see Figure 6.1-4). After impact, the debris broke into multiple pieces that fell along the Solid Rocket Booster exhaust plume.¹⁵ Post-mission inspection of the Solid Rocket Booster confirmed damage to foam on the forward face of the External Tank Attachment ring. The impact was approximately 4 inches wide and 3 inches deep. Post-External Tank separation photography by the crew showed that a 4- by 5- by 12-inch (240 cubic-inch) corner section of the left bipod ramp was missing, which exposed the super lightweight ablator coating on the bipod housing. This missing chunk of foam was believed to be the debris that impacted the External Tank Attachment ring during ascent. The post-launch review of photos and video identified these debris events, but the Mission Evaluation Room logs and Mission Management Team minutes do not reflect any discussions of them.

Figure 6.1-4. On STS-112, the foam impacted the External Tank Attach ring on the Solid Rocket Booster, causing this tear in the insulation on the ring.

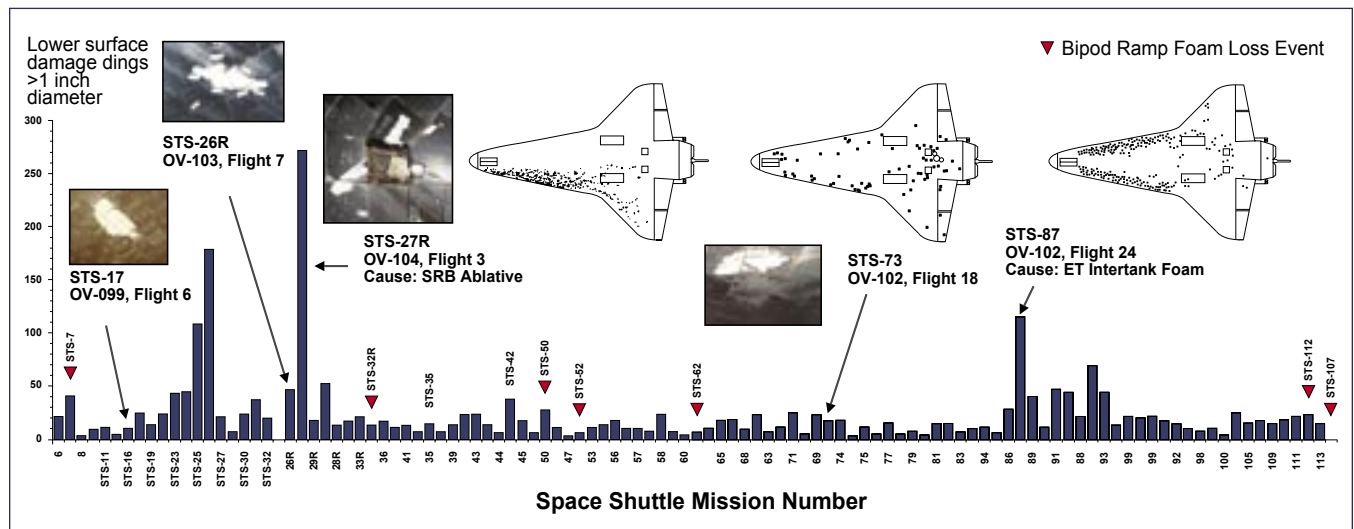
Figure 6.1-6. This chart shows the number of dings greater than one inch in diameter on the lower surface of the Orbiter after each mission from STS-6 through STS-113. Flights where the bipod ramp foam is known to have come off are marked with a red triangle.

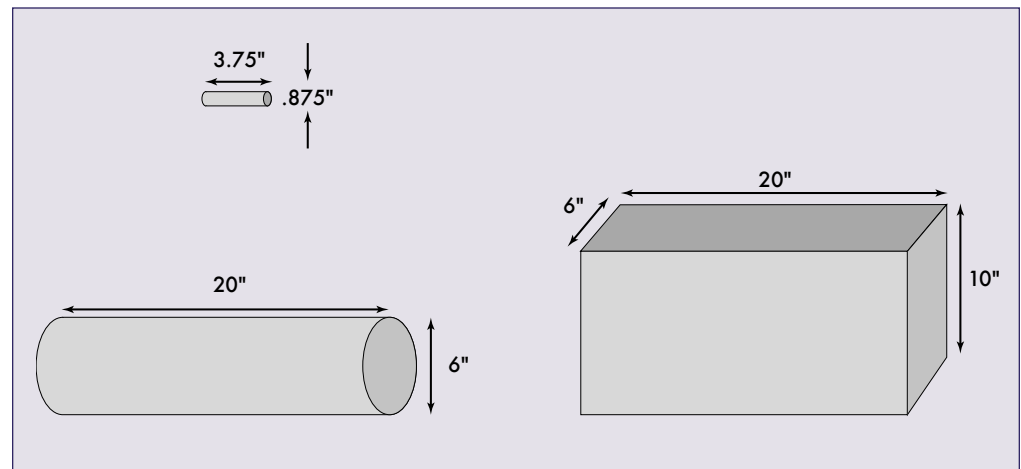
Until STS-107, Crater was normally used only to predict whether small debris, usually ice on the External Tank, would pose a threat to the Orbiter during launch. The use of Crater to assess the damage caused by foam during the launch of STS-107 was the first use of the model while a mission was on orbit. Also of note is that engineers used Crater during STS-107 to analyze a piece of debris that was at maximum 640 times larger in volume than the pieces of debris used to calibrate and validate the Crater model (the Board's best estimate is that it actually was 400 times larger). Therefore, the use of Crater in this new and very different situation compromised NASA's ability to accurately predict debris damage in ways that Debris Assessment Team engineers did not fully comprehend (see Figure 6.3-1).

Figure 6.3-1. The small cylinder at top illustrates the size of debris Crater was intended to analyze. The larger cylinder was used for the STS-107 analysis; the block at right is the estimated size of the foam.
